CASE STUDY 5

Background

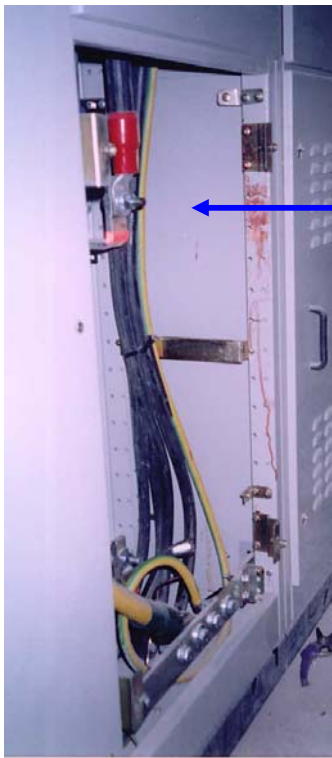
Two moulded case circuit breakers (MCCBs), rated at 500-Amp and 300-Amp respectively, were installed one above the other in the upper compartment of the switchboard; the busbars were located in the lower compartment below the MCCBs. The 500-Amp MCCB was at switched-on position serving some outgoing circuits. The worker was installing CTs for the 300-Amp MCCB at the back of the switchboard with all the live circuits exposed. While fixing the third CT, the worker's shoulder inadvertently came into contact with one of the live terminals of the 500-Amp MCCB and he received a fatal electric shock.

Live terminals of the 500-Amp MCCB were not covered with insulating barrier while work was being carried out at the lower compartment of the panel.

- The 500-Amp MCCB should have been switched off while work was being carried out on the 300-Amp MCCB below it.
- If switching off the 500-Amp MCCB is not possible or desirable, appropriate insulating barriers should be provided to prevent access to or accidental contact with any of the exposed live parts of the 500-Amp MCCB.
